Essex County Council Flood Investigation Report

Bromley Road
Frating

Introduction

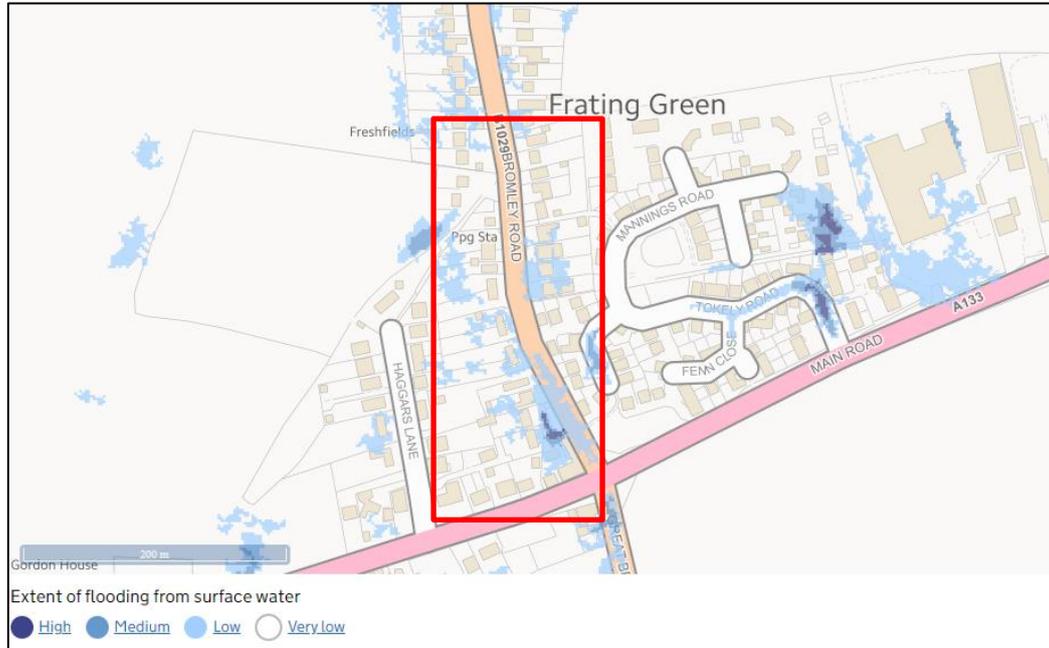
Figure 1 – Flood Investigation Area shown in red and Risk of Flooding Surface Water (Base Map: Ordnance Survey, 2014; Flood Map: Environment Agency, 2021).

Properties have flooded internally along Bromley Road, Frating. Figure 1 shows that most of the investigation area has a very low of risk of flooding from surface water; very low risk means that each year this area has a chance of flooding of less than 0.1% (fig.1).

The highway is shown as having little to no flood risk with isolated areas of high risk flooding occurring in localised areas of gardens and fields. High risk means that each year this area has a chance of flooding of greater than 3.3%. The flood depth in some locations during this event is predicted to be between 300-900mm in places. The surface water flood risk can be viewed [here](#).

Whilst the mapping in figure 1 is a good indicator of risk, due to lack of specific detail on the local drainage system and permeability it is not suitable for a detailed assessment of individual properties. Risk of flooding from surface water is hard to predict as rainfall location and volume are difficult to forecast. In addition, local topography, ground conditions, soil type and the type and location of drainage features can greatly affect the chance and severity of flooding.

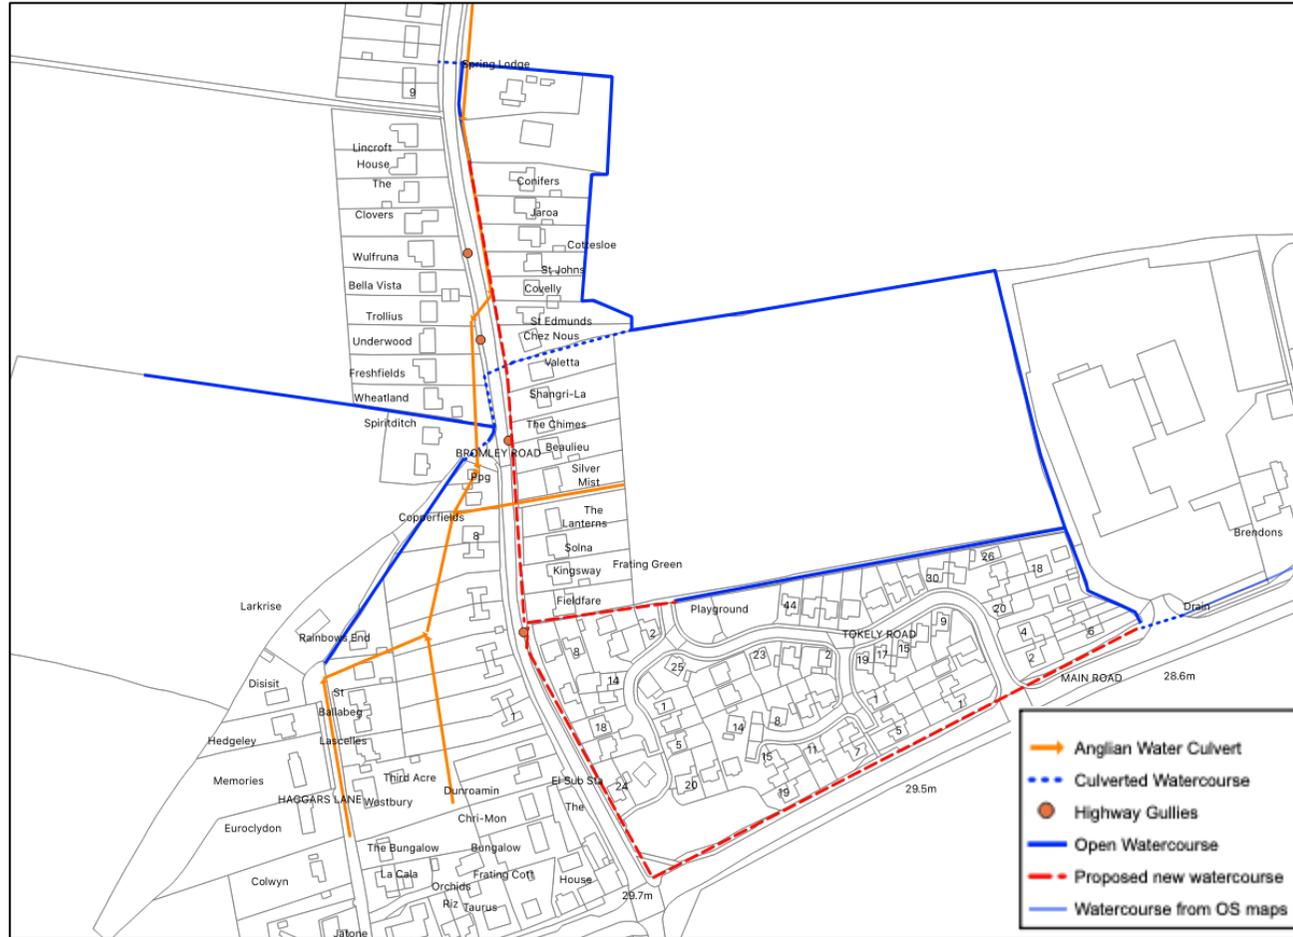
Figure 2 – Indicative Drainage Layout (Ordnance Survey, 2021).

Figure 2 shows the indicative layout of the primary drainage infrastructure in the area, the information was obtained from Environment Agency (EA) Detailed River Network (DRN) Mapping, EH, Anglian Water and site observations.

Much of the drainage infrastructure in the area consists of open watercourses, with sections of culvert on private land, alongside an Anglian Water maintained sewerage system. Frating is sited at the top of a catchment boundary with minimal topographic changes producing slow flowing drainage in the area.

During the site inspection in February 2021 open watercourses were noted to exist either side of Bromley Road. Water is believed to drain east towards Bentley Brook which is classed as main river and under the jurisdiction of the Environment Agency. Open watercourses on the eastern side of the Bromley Road behind properties called Spring Lodge along to Chez Nous appeared to be well maintained. Those to the rear of the Tokely Road development appeared to be in poor condition and overgrown, minimal viewing was available from Main Road. Watercourses along Main Road also appeared to be overgrown although of good proportions. These sections would be riparian maintained and have been passed onto the Watercourse Regulation Engineer to review and take possible enforcement. Open watercourses to the east of Bromley Road appeared to be in a fair condition and not a cause for concern.

Proposed new watercourse based on historic maps, further explained in possible causes section below under 'Development'.

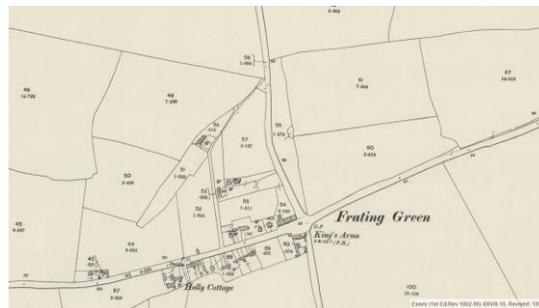
(OS 25 Inch 1892-1914)

Comparing the historic mapping to current mapping it is noticeable that there are several historical field boundaries. It is possible these are an indication of historic watercourses and due to the change in land use these may no longer exist. With a potential decrease in watercourses and the addition of areas of impermeable hardstanding associated with development it is likely to have exacerbated the speed and volume of flows. This would also marry with local knowledge stating that there was historically a watercourse along the eastern edge of the highway. It would therefore be recommended to create new watercourses as mapped in the section above.

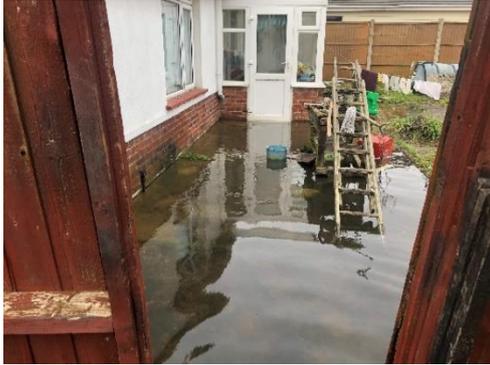
Kingsway suffering internal flooding

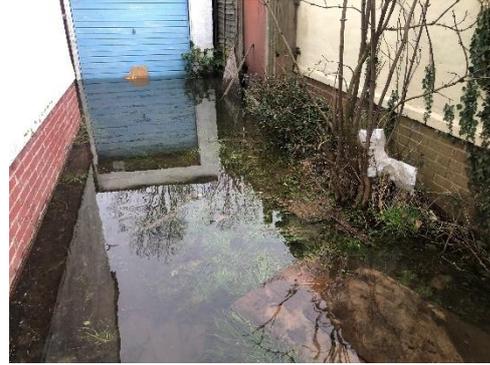
Garage of Kingsway during flood

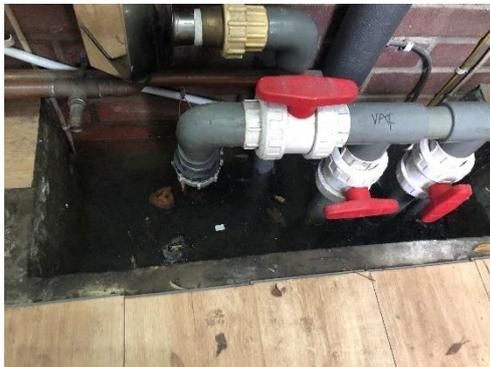
Ground water within Fieldfare

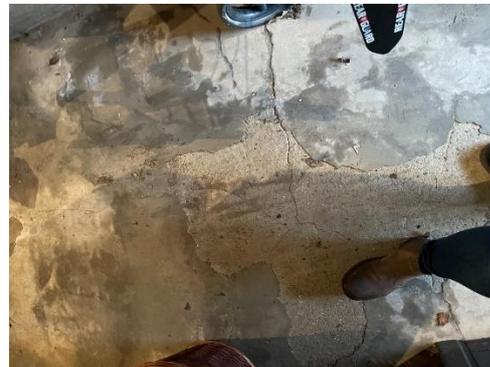
Damage to Garage foundations Fieldfare

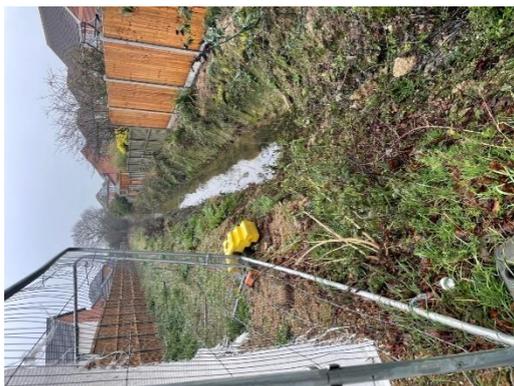
Watercourse to the rear of Fieldfare

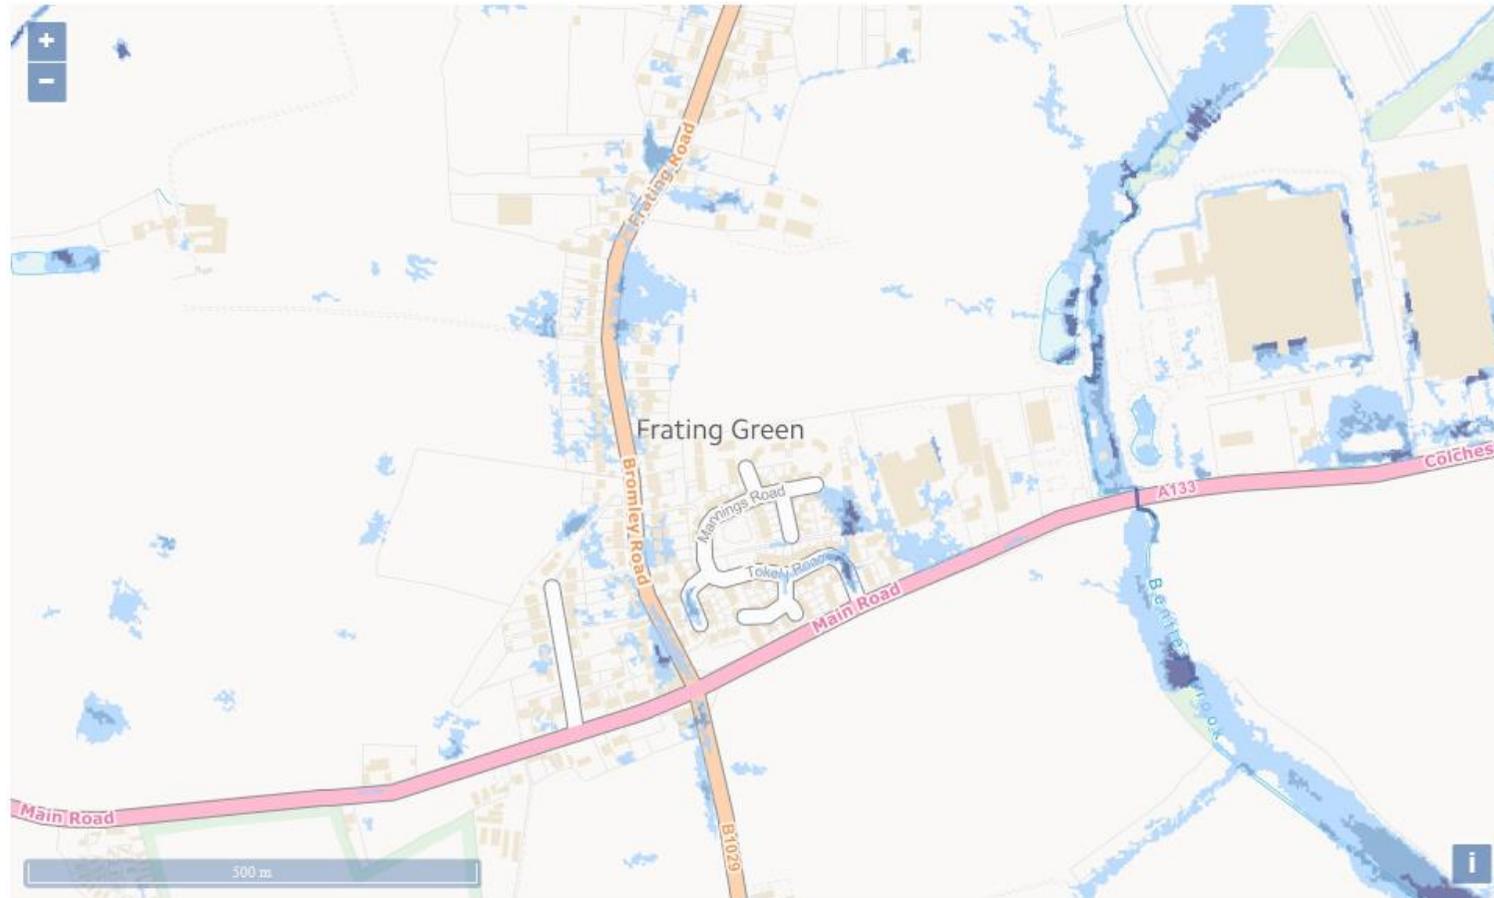
Extent of flooding from surface water
